**SUBSTATION GROUNDING SYSTEM EVALUATION
CONDUCTED BY VIRGINIA POWER**

PRESENTED BY: F. W. Edwards

Virginia Power

**Southeastern Electric Exchange
New Orleans, Louisiana
May 27, 1993**

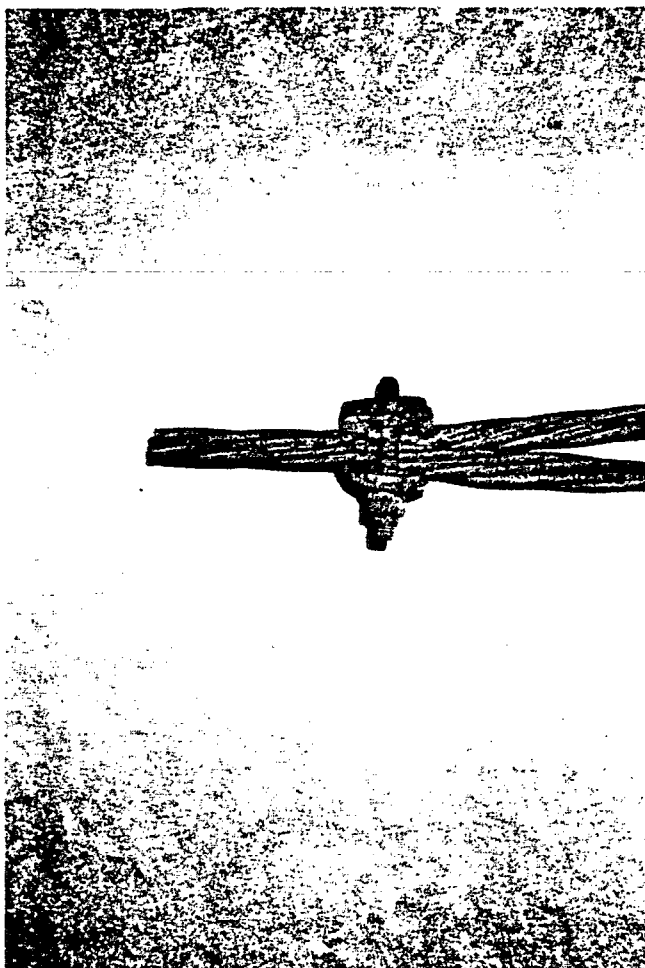
FIGURE 10
Conductors not properly installed between
saddles of the connector, creating high
resistance current paths.

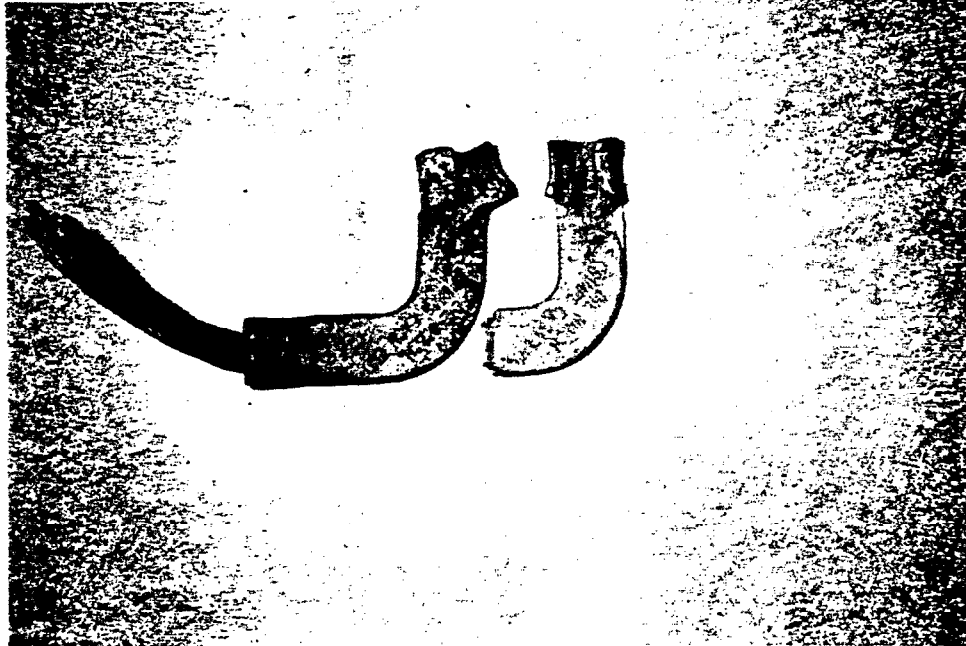
- a. Compression tools did not apply sufficient compressive forces. **FIGURE 5**
- b. Use of incorrect dies.
- c. Connector was not properly installed. **FIGURE 6**
- d. Conductor was not properly cleaned.
- e. Lack of corrosion inhibitor or inhibitor failure. **FIGURE 7**
- f. Repeated high current surges deteriorated connections.

FIGURE 7
Current path corroded due to inhibitor
failure.

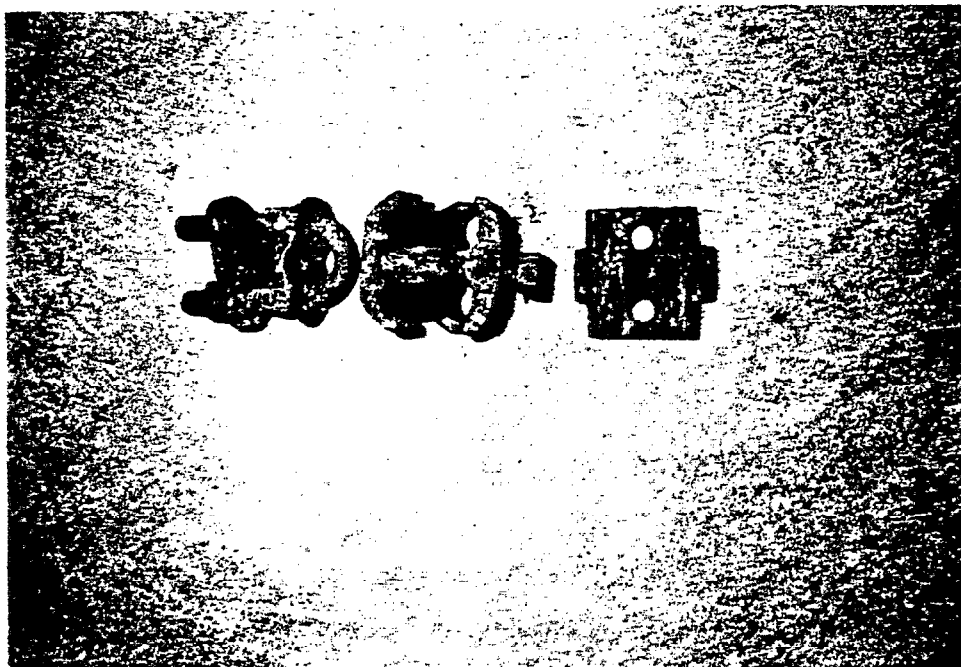
- a. Most low resistivity corrosion resistant materials provide low clamping forces could not withstand the expansive forces generated by the corrosion process. Others were installed with too little clamping force or over-stressed to yield point of the fastener. **FIGURES 8 & 9**
- b. Connector was not properly installed. **FIGURES 10 & 11**
- c. Conductor was not properly cleaned.
- d. Lack of corrosion inhibitor or inhibitor failure.
- e. Repeated high current surges deteriorated connections.

FIGURE 8
Inhibitor failure allowed expansive forces
of corrosion to create high resistance
current path.

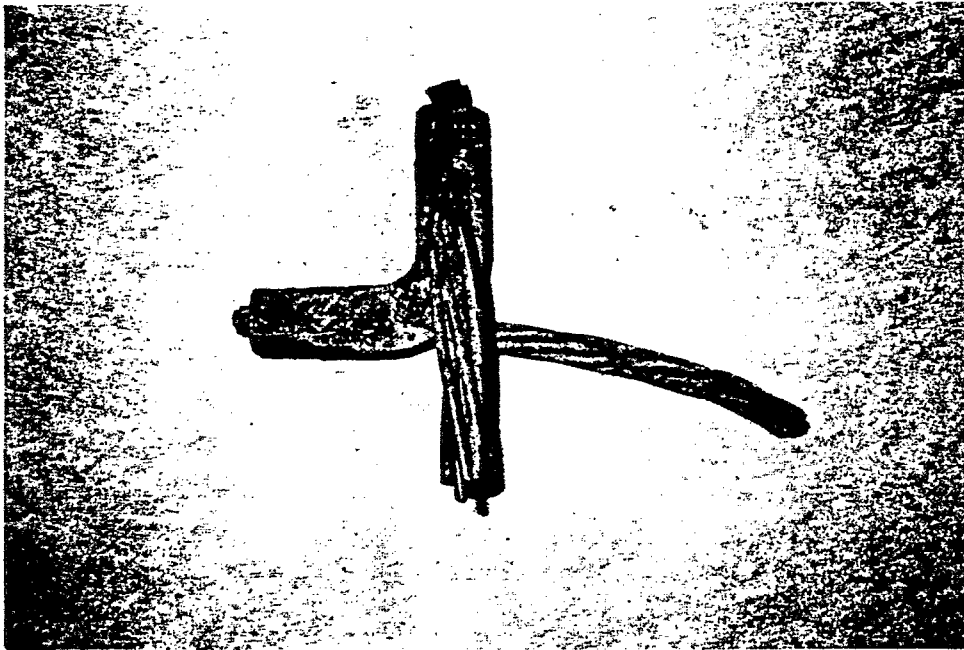
FIGURE 5
Conductor was not fully enclosed due to
insufficient compressive force.

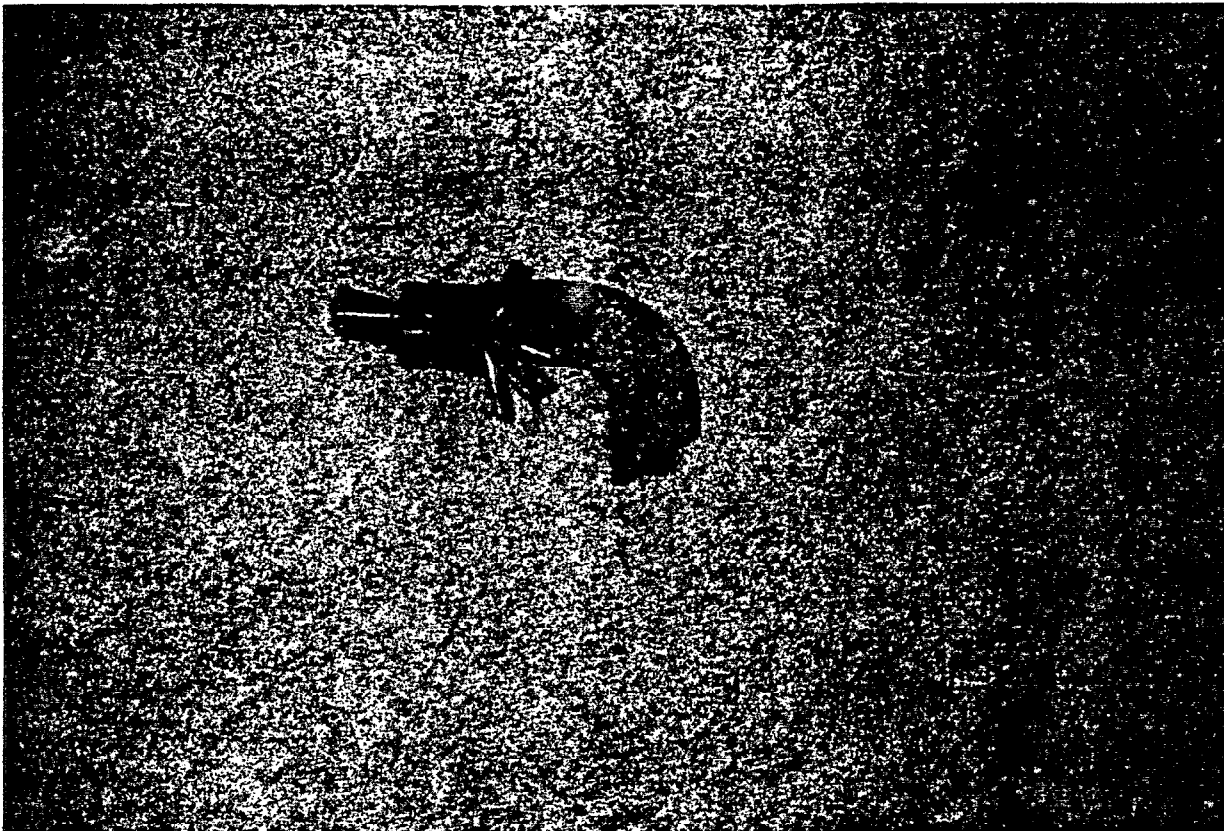
FIGURE 6
Connector was not properly installed on
conductor, exposed stranding prevented
die from closing correctly.
