**SUBSTATION GROUNDING SYSTEM EVALUATION
CONDUCTED BY VIRGINIA POWER**

PRESENTED BY: F. W. Edwards

Virginia Power

**Southeastern Electric Exchange
New Orleans, Louisiana
May 27, 1993**

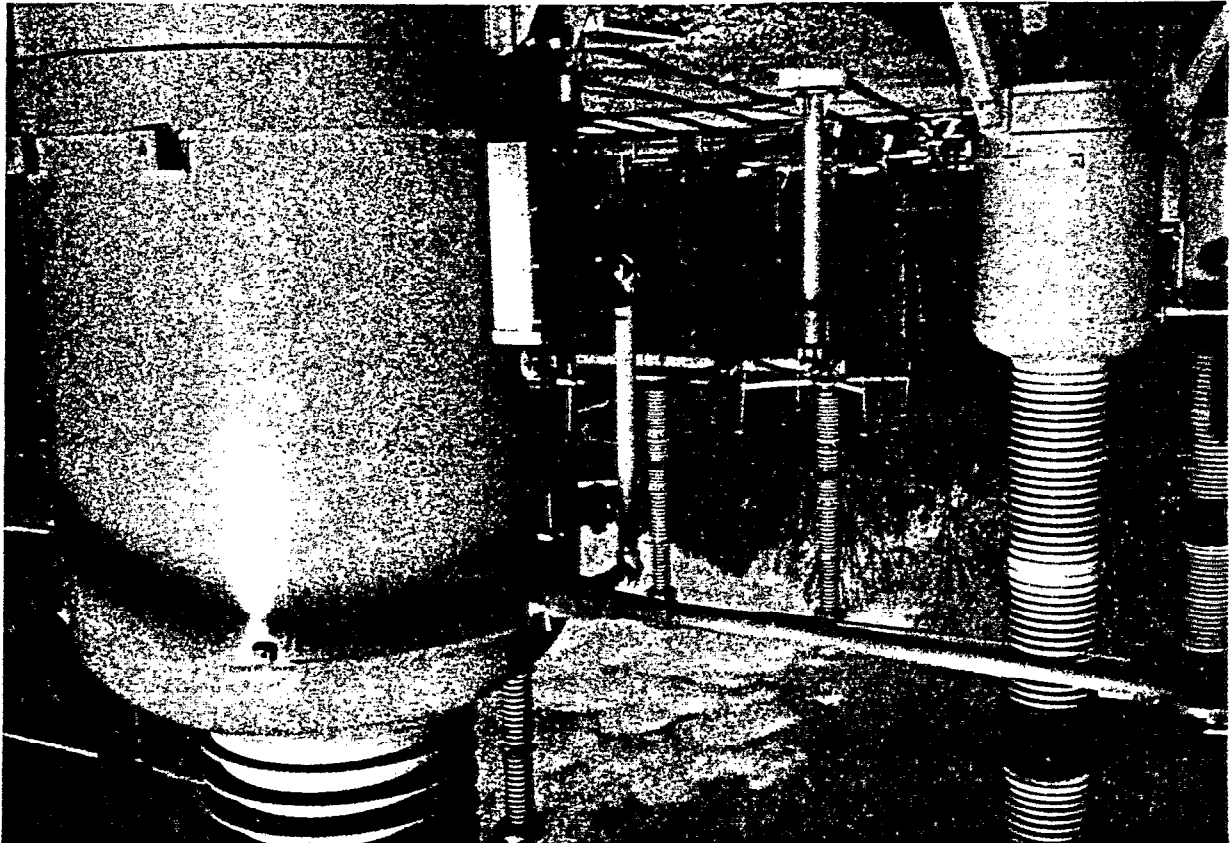
FIGURE 3
Damage to grid isolated 500 kv CT, creating
non-intentional ground path through the
conduit and 1/8 inch stainless steel tubing
in the SF6 system.
